ALL POINTS HOME INSPECTION

CONFIDENTIAL INSPECTION REPORT

4455 Ravine Dr., Vacaville, CA.

11/20/2014

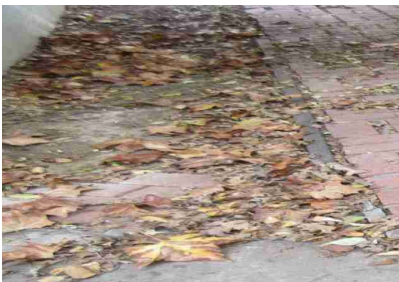
- 1.1 - Grading and drainage is either negative or neutral adjacent to the residence, and moisture intrusion into the crawlspace will remain a possibility. The soil or the hard surfaces should slope away from the residence to a distance of at least six feet, to keep moisture away from the footings.

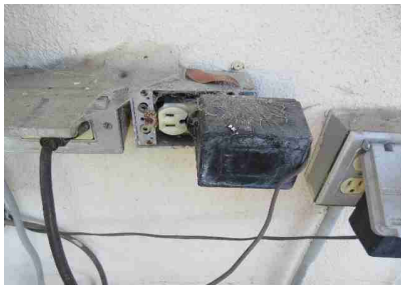
1.3 - An outlet in the side yard needs a exterior cover.

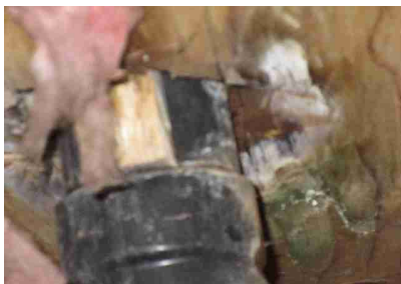
2.1 - There are stains or moisture damage to the sub-floor beneath a bathroom. The termite inspector should evaluate and comment on the condition of the intermediate floor framing.

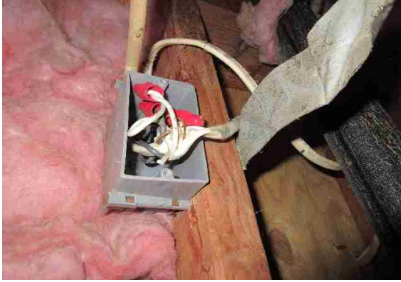
2.2 - There is an open electrical junction box within the crawlspace, which should be sealed so that any arcing or sparking would be contained within the box.

There is an open electrical junction box within the crawlspace that should be sealed - *Continued*

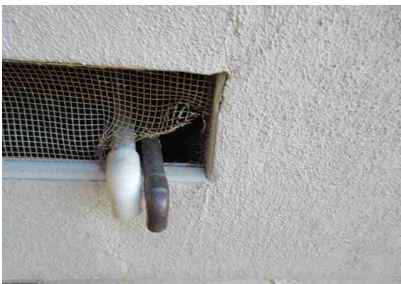
- 2.3 - The crawlspace is not adequately ventilated, which is a major contributor to the moisture problem. There are several vent ports that have been blocked by insulation.
- 2.4 - One or more of the foundation ventilation screens are damaged or missing, and should be repaired or replaced to keep rodents and other pests out.

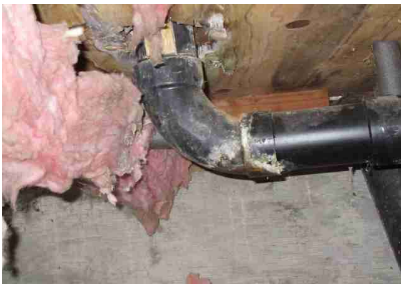
5.1 - There is a leak below the master toilet.

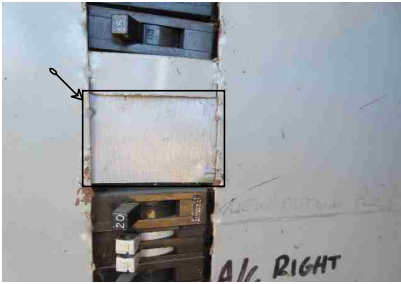
6.1 - The interior cover panel has voids or open knockouts that should be covered. - duct tape is not a fix

The interior panel cover has voids that should be covered - *Continued*

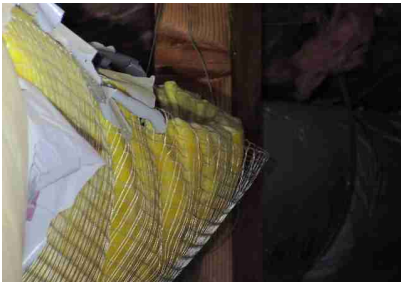
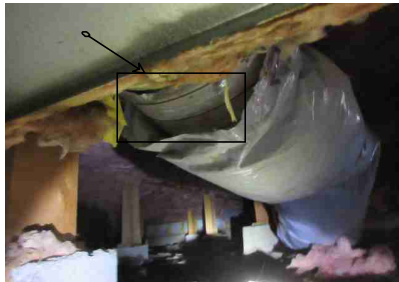
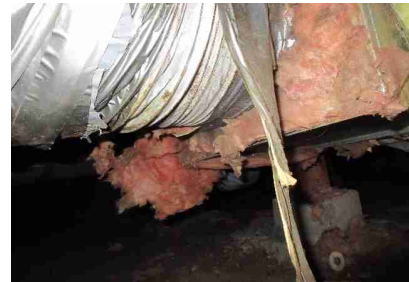
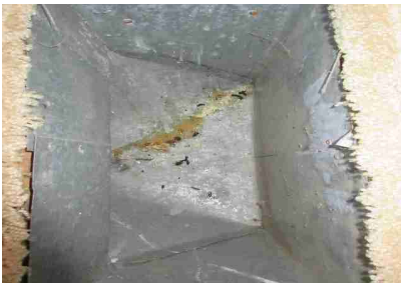
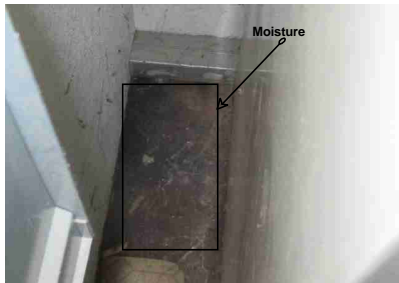
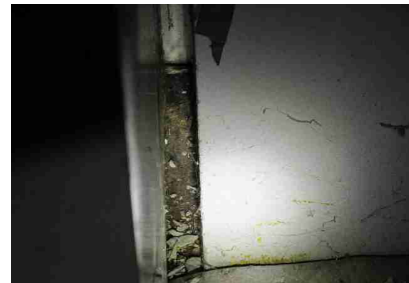
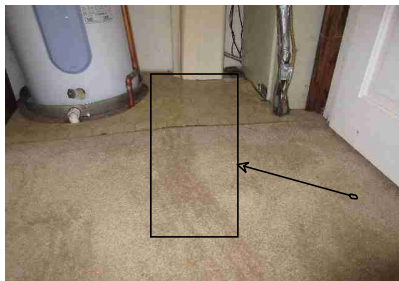
* There are various issues or deficiencies within the system. The duct work needs repair and it appears to have been compromised by rodents, both units appear to be leaking as evidenced by the moisture damaged floor around them

8.1 - For the reasons indicated in this report, * the split-systems need to be further evaluated and serviced. This service should be scheduled within the inspection period, because a specialist might reveal additional defects or recommend upgrades that could affect your evaluation of the systems.

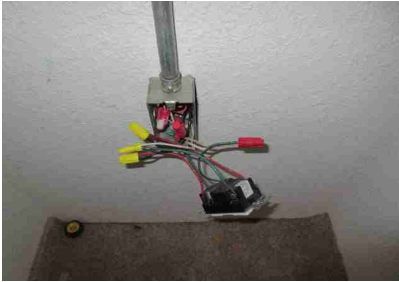
9.1 - The outlet has open wire and should be serviced.

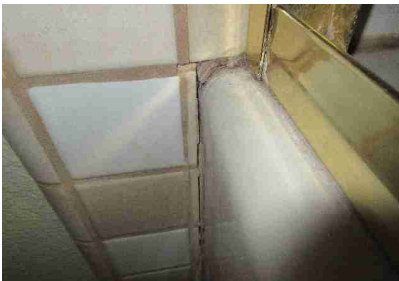
- 13.8 - There are open grout-joints in the tiles around the tub area of the master bathroom that should be sealed to prevent moisture damage.

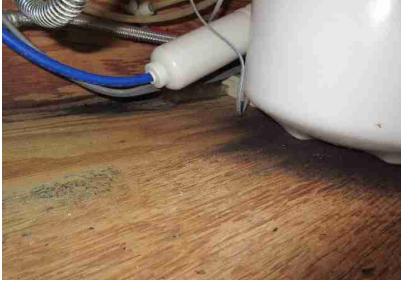
- 14.1 - The floor of the sink cabinet is functional, but moisture damaged .There is a mold-like substance present that should be removed.

The floor of the sink cabinet is functional but moisture damaged - *Continued*

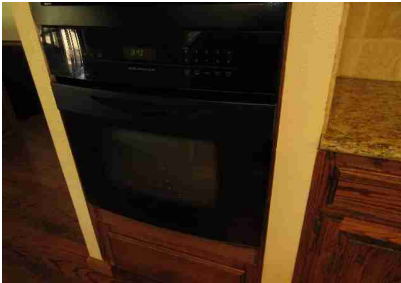
14.2 - The door on the built-in, electrical, oven does not seal effectively, which could affect its performance and should be serviced.

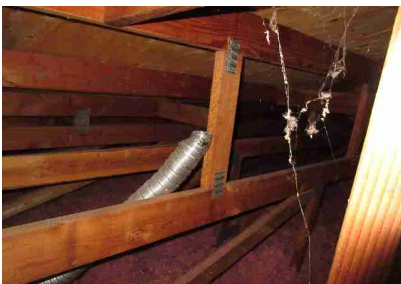
16.1 - The bathroom exhaust duct should be extended to an exterior vent port.

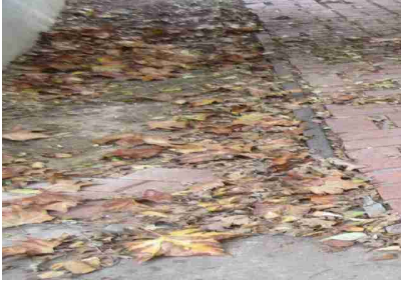
1.3 - Grading and drainage is either negative or neutral adjacent to the residence, and moisture intrusion into the crawlspace will remain a possibility. The soil or the hard surfaces should slope away from the residence to a distance of at least six feet, to keep moisture away from the footings.

Grading and drainage is negative or neutral adjacent to the residence and should be monitored - *Continued*

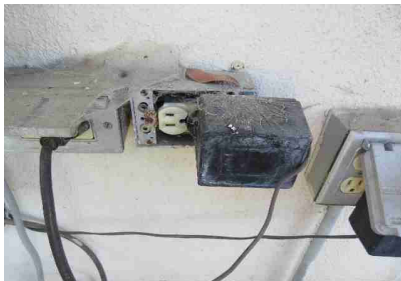
1.12 - An outlet in the side yard needs a exterior cover.

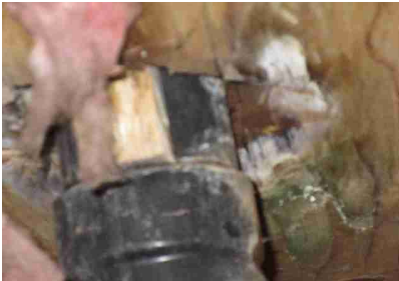
2.8 - There are stains or moisture damage to the sub-floor beneath a bathroom. The termite inspector should evaluate and comment on the condition of the intermediate floor framing.

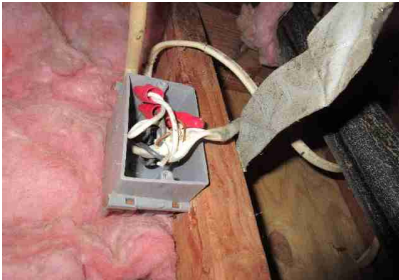
2.9 - There is an open electrical junction box within the crawlspace, which should be sealed so that any arcing or sparking would be contained within the box.

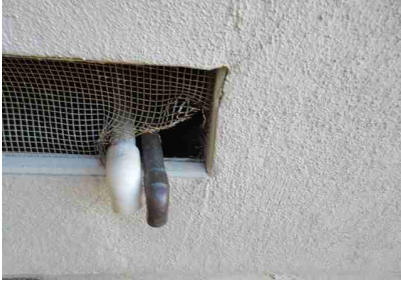
2.10 - The crawlspace is not adequately ventilated, which is a major contributor to the moisture problem. There are several vent ports that have been blocked by insulation.

2.11 - One or more of the foundation ventilation screens are damaged or missing, and should be repaired or replaced to keep rodents and other pests out.

Several of the foundation ventilation screens are damaged or missing and should be repaired or replaced - *Continued*

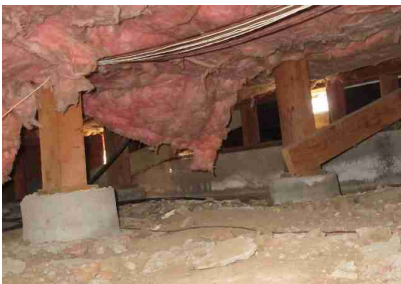
2.12 - Some pieces of insulation are hanging or have fallen from between the floor joists. This does not have any serious consequences, but you may wish to have it serviced.

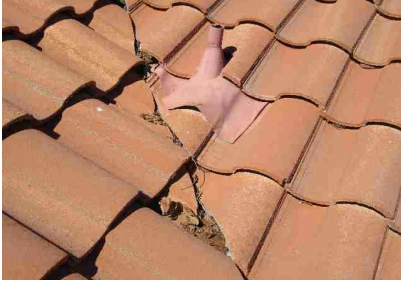
3.5 - The valley or roof to wall flashings need to be cleaned and kept clean to forestall moisture intrusion.

The valley flashings need to be cleaned and kept clean - *Continued*

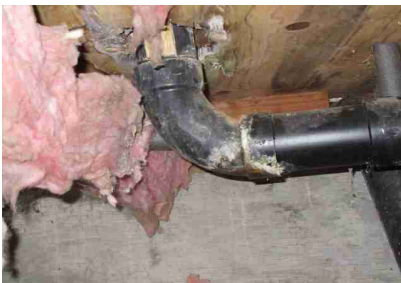
5.11 - There is a leak below the master toilet.

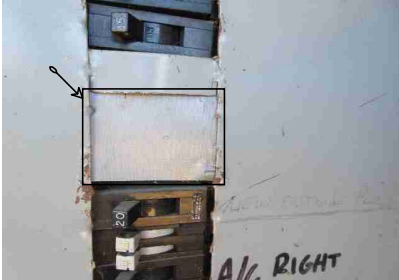
6.4 - The interior cover panel has voids or open knockouts that should be covered. - duct tape is not a fix

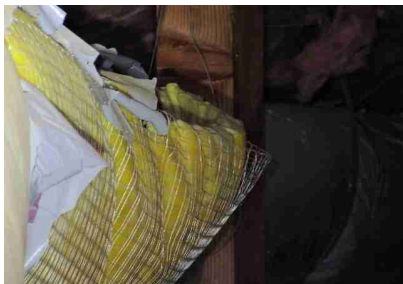
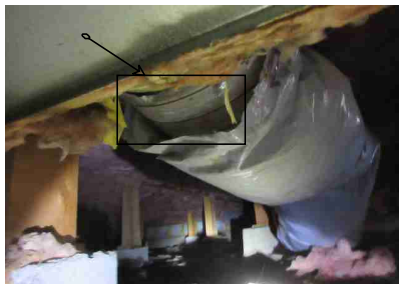
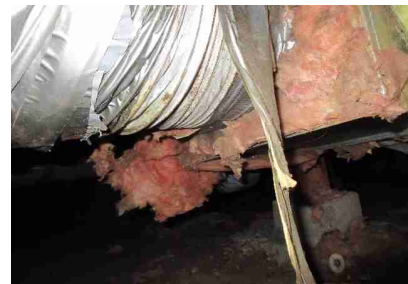
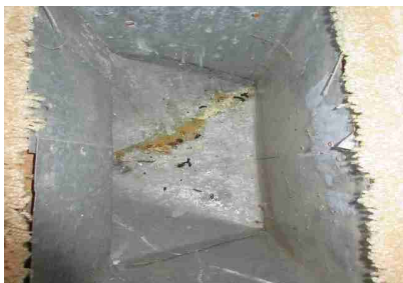
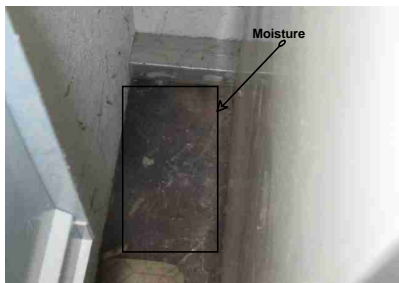
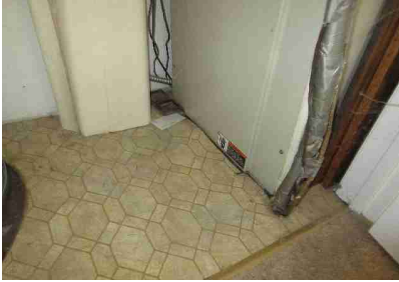
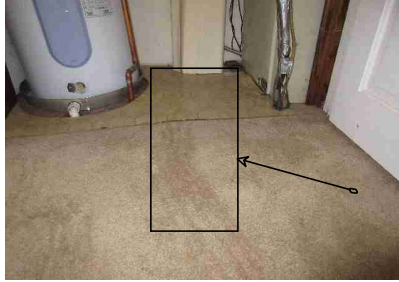
* There are various issues or deficiencies within the system. The duct work needs repair and it appears to have been compromised by rodents, both units appear to be leaking as evidenced by the moisture damaged floor around them

8.1 - For the reasons indicated in this report, * the split-systems need to be further evaluated and serviced. This service should be scheduled within the inspection period, because a specialist might reveal additional defects or recommend upgrades that could affect your evaluation of the systems.

The split-system should be serviced before the close of escrow - *Continued*

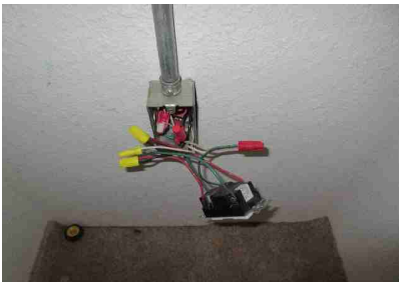
9.1 - The outlet has open wire and should be serviced.

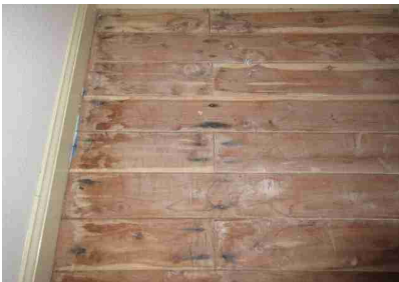
12.5 - The floor is moisture stained in the closet. Unable to determine a reason. It does not appear to be coming from an exterior source.

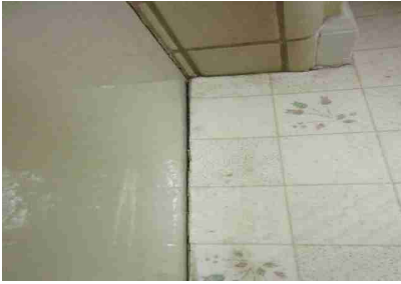
13.12 - The floor seams are lifting, due to moisture penetration or poor workmanship.

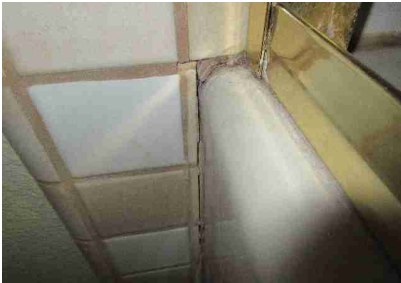
13.13 - There are open grout-joints in the tiles around the tub area of the master bathroom that should be sealed to prevent moisture damage.

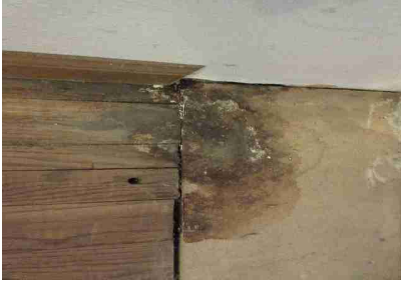
14.2 - The floor is moisture damaged at the frig area. There is not current leak. There is a small amount of a mold-like substance that should be removed.

The floor is moisture damaged - *Continued*

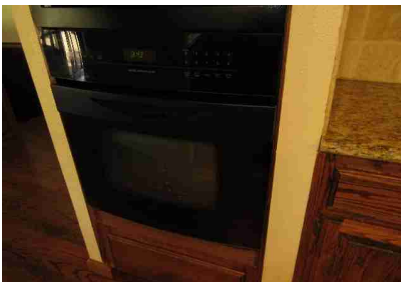
14.5 - The door on the built-in, electrical, oven does not seal effectively, which could affect its performance and should be serviced.

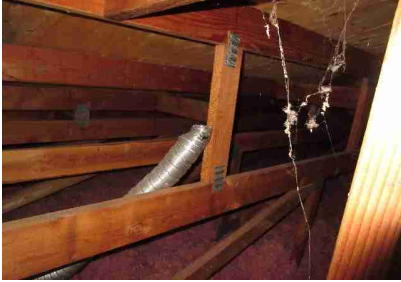
16.4 - The bathroom exhaust duct should be extended to an exterior vent port.

The bathroom exhaust duct should be extended to an exterior vent port - *Continued*
